ANALYSIS OF OBSERVED SEISMIC DAMAGES ON HISTORIC ADOBE-MUD BRICK STRUCTURES OF BAM CITADEL, AFFECTED BY THE 2003 BAM EARTHQUAKE

\*Jafar Rouhi, Bianca Gioia Marino and Aldo Aveta

University of Naples Federico II, Italy

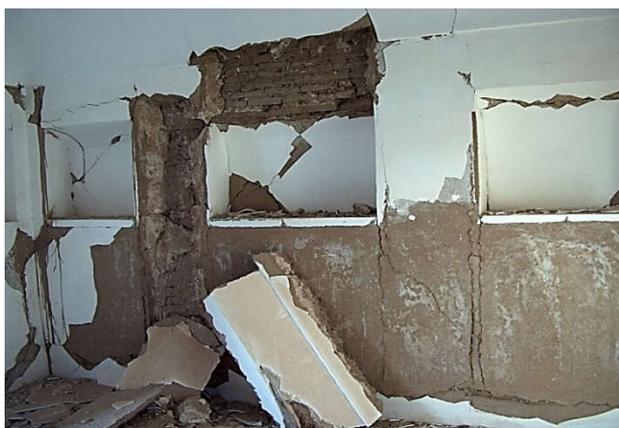
**Figure 1. Damage on adobe surface coating in the Mirza Na'im School of Bam Citadel (Source: personal archive of Prof. Luigi Marino, 2007)**

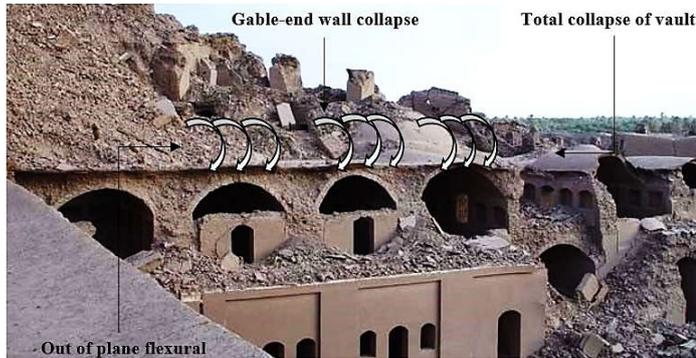
During prolonged ground motions, because gravity is constantly working in combination with earthquake forces, the bending about the vertical axis first causes a splitting-crushing cycle generating vertical cracks, and then by bending about the horizontal axis, the upper part of wall panel will overturn. In fact, the probability of out of plane flexural cracks and collapses in non-load-bearing walls are more than load-bearing walls due to lack of fixed ending. In Bam Citadel, numerous examples of out-of-plane flexural damages have been observed in Citadel's surrounding fortification.

Figure 2. Different types of out-of-plane damage on the Barrack of Bam Citadel (Source: archive of ICHHTO, 2003, designed by Author)

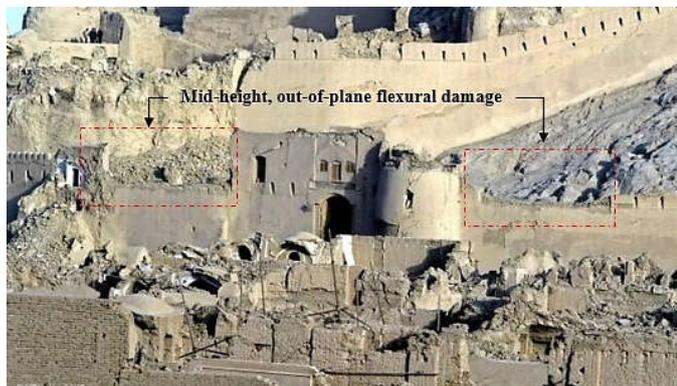
A particular case of out-of-plane flexural damage occurs when the adobe wall have low thickness ratios ( $L = \frac{l = \text{length}}{d = \text{width}}$ ). When the load-bearing and non-load bearing adobe walls are long and slender, by development of horizontal cracks along the base and their combination with vertical cracks, the mid-height, out-of-plane flexural damage might occur.

Figure 3. Mid-height, out-of-plane flexural damage in second wall of Bam Citadel (Source: archive of Gettyimages, 2004. Source: <http://www.gettyimages.it/immagine/bam-citadel?>, designed by Author)

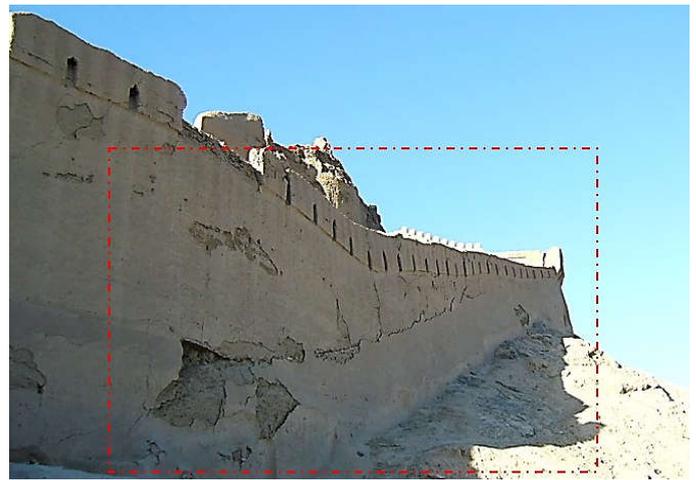
Figure 4. Mid-height, out-of-plane flexural damage without collapse in third defensive wall of Bam Citadel. Fortunately as can be seen, the horizontal and vertical cracks across the length of wall could not cause to detachment of wall, if the seismic motion had been more prolonged, the total collapse of wall might have occurred (Source: archive of ICHHTO)

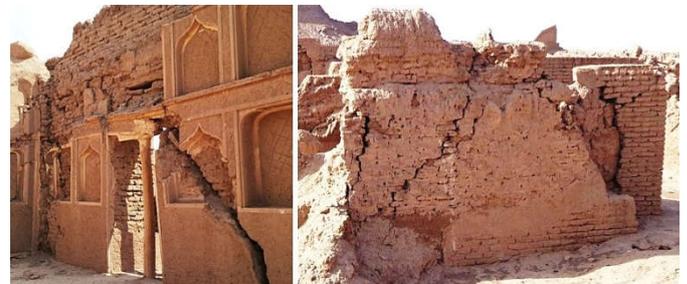
The X-shape in-plane cracks occur when the sequence of ground motions cause the shear forces to go in one direction and then go in the opposite direction. In this case, later when the adobe walls have cracked, the continuation of seismic movement might exacerbate the damage and cause independent collapse of the walls in an out-of-plane mode. More severe damage to the structure may occur when an in-plane horizontal offset occurs in combination with a vertical displacement (i.e., when the crack pattern follows a more direct diagonal line and does not stair-step along mortar joints) (Tolles *et al.*, 1996).

Figure 5. The in-plane shear cracks in Bam Citadel after the 2003 Bam earthquake (Photos by Rouhi, 2015)

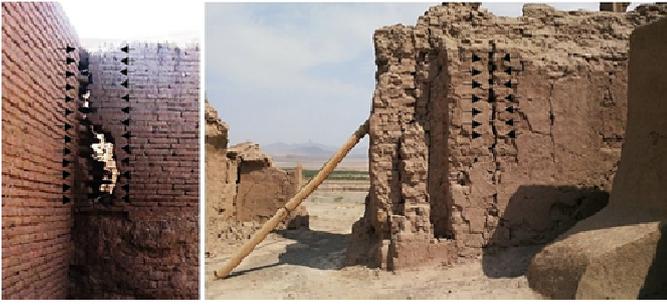
This damage often occurs as vertical cracks or gaps appear in the wall connections at the intersection between the façade walls and the perpendicular walls, where the connections between components are too weak to withstand against the earthquake demands. In this case, while the perpendicular wall remains very stiff in plane, one of the connected walls rocks out of plane. During large ground motions, this process triggers the walls to the post-failure overturning of the wall panels. This type of damage is one of the most inevitable collapse mechanism of adobe walls under seismic motions. Observations made after the Bam earthquake have shown that the magnitude of damage suffered by the monuments in Bam Citadel was directly related to quality of the connection, and the damages had been more significant where large cracks were associated with damages that occurred in roofs.

Figure 6. Intersection of perpendicular walls in Bam Citadel after the 2003 Bam earthquake (Photos by Rouhi, 2015)

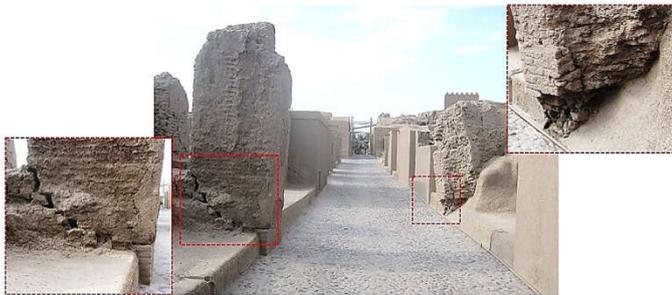
Cracks caused by seismic motions often occur in locations with high stress concentrations. Cracks in corners of an adobe building are very common because relative response is largest at the wall's interfaces. That is why the probability for occurrence of cracks at the corners of buildings during an earthquake is more than other parts. A thin adobe wall may become unstable soon after the initiation of cracks through the wall. However, a thick-walled adobe building is still a long way from losing its stability after the first cracks develop (Tolles *et al.*, 1996). The extent of damage caused in a building will depend on the width of the crack generally characterized as hairline cracks, fine cracks, moderate cracks, extensively damaged cracks and structural cracks (Varum *et al.*, 2014). It should be noted that, since adobe materials have high adhesion properties, any cracks could not cause serious damages.

Figure 7. High adhesion of seismic damaged adobe wall in the Bazaar of Bam Citadel (Photos by Rouhi, 2015)

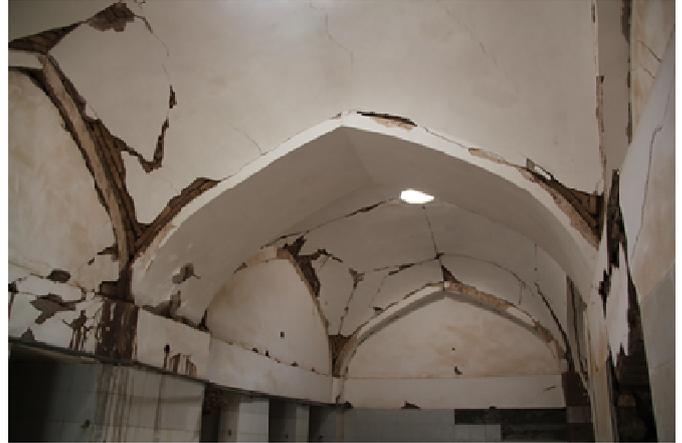
- Vertical cracks at corners: vertical cracks often develop at corners during the interaction of perpendicular walls and are caused by flexure and tension due to out-of-plane movements. This type of damage can be particularly severe when vertical cracks occur on both faces allowing collapse of the wall section at the corner.
- Diagonal cracks at corners: diagonal cracks that start at the top of a wall and extend downward to the corner are caused by in-plane shear forces. This type of crack results in a wall section that can move laterally and downward during extended ground motions. This type of damage is difficult to repair and may require reconstruction.
- Combinations with other cracks or preexisting damage: the combination of diagonal cracks and vertical cracks can leave an adobe wall severely fractured with several

sections of the adobe wall susceptible to large offsets and/or collapse. The diagonal cracking at that location is at the southwest corner of the buildings leaving the cracked wall sections free to move outward. Corners may be more susceptible to collapse if vertical cracks develop and the base of the wall has already been weakened by previous moisture damage.

Figure 8. Different types of cracks in Mirza Naem School of Bam Citadel after the 2003 Bam earthquake (Photo by Rouhi 2015)

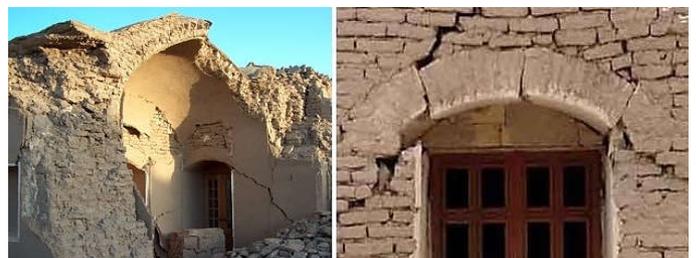
An opening in a frontage constitutes a vulnerable point in the event of deformation of the adobe frame. The cracks of the front walls are found in the contours of the openings, where the stresses are most significant and in particular close to the re-entrant angles (NIKER, D3.1, 2010). Since more often during seismic motions, cracks occur in locations that stress concentrations are high, the openings are deep interested in cracks phenomena. Usually, these cracks start at the top or bottom corners of openings and develop vertically, diagonally and horizontally to the tops or bases of the walls. In adobe building, cracks over the openings may be hazardous to occupants if they are dislodged. The best way to control cracks at openings is keeping the openings in the walls small and well-spaced.

Figure 9. Crack at opening of Bam Citadel after the 2003 Bam earthquake (Source: (Left) personal archive of Prof. Luigi Marino; and (Right) Auroville Earth Institute "BAM AND ARG-E-BAM", after the 2003 Bam earthquake)

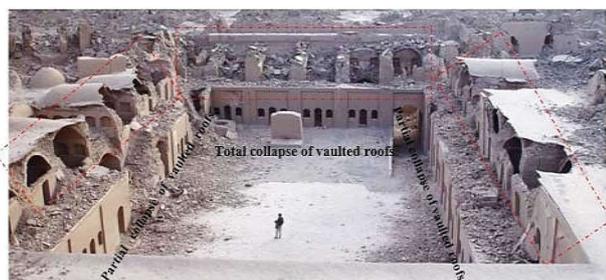
Figure 11. Total and partial collapse in the Barrack of Bam Citadel after the 2003 Bam earthquake (photo by Ahmadi and Boroomandi, 2003. Source: archive of ICHHTO, designed by Author)

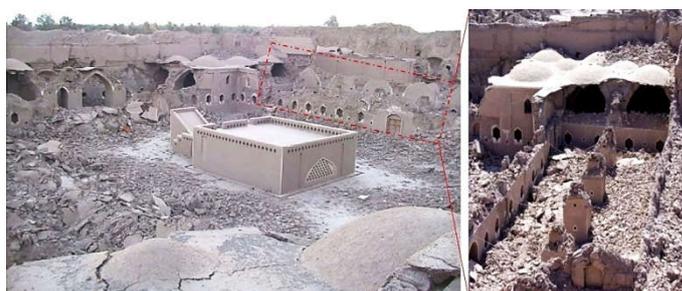
Unlike the vaulted roofs that have shown variable damage typologies by the earthquake, most of the domed roofs in Bam Citadel faced complete destruction, and a small number of domes faced low failure in their façade. An example of such total destruction can be seen in the Stable of Bam Citadel, where almost all of its domes totally collapsed. As Langenbach (2004) pointed out, "the collapse of the domes throughout the complex, many simply may have followed their bursting supporting walls to the ground. Others that collapsed inwardly, such as the icehouse, probably suffered from the effect of the intense vertical vibrations on the weak unfired brick masonry. The momentary doubling of the weight of the domed structures was probably more than they could handle. The bricks themselves were simply too small and weak to form enough of a resisting arch."

Figure 12. Damage on domed roof in the Stable of Bam Citadel after the 2003 Bam earthquake (Source: archive of RPBCH, designed by Author)

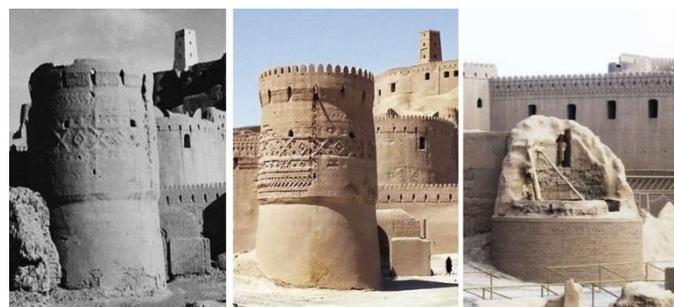
Figure 13. The condition of east-south tower of the Stable of Bam Citadel in different periods before and after earthquake (Sources: archive of ICHHTO, before the 2003 Bam earthquake; and Rouhi, 2015)

façade of towers. In most cases, by development of cracks, the towers were subject to detachment in their connection with

side walls. Here due to the large vertical acceleration of the earthquake, the upper portion of most towers were substantially damaged.
