CASE REPORT

ESTHETIC REHABILITATION OF STRUCTURALLY COMPROMISED ANTERIOR TOOTH USING FIBRE REINFORCED COMPOSITE

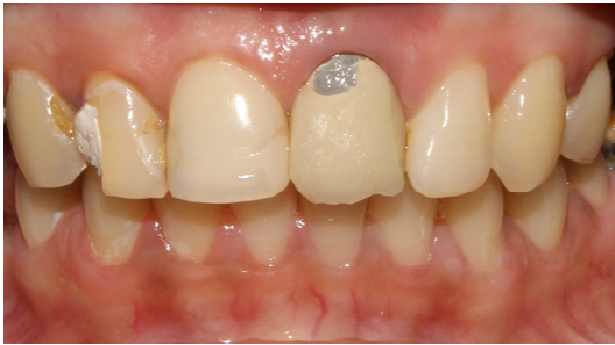
A 32 year old female patient presented to the Department of Conservative dentistry and Endodontics with a chief complaint of unaesthetic, ill-fitting mobile crown in relation to maxillary left central incisor (Figure 1).

Figure 1. Preoperative intraoral view

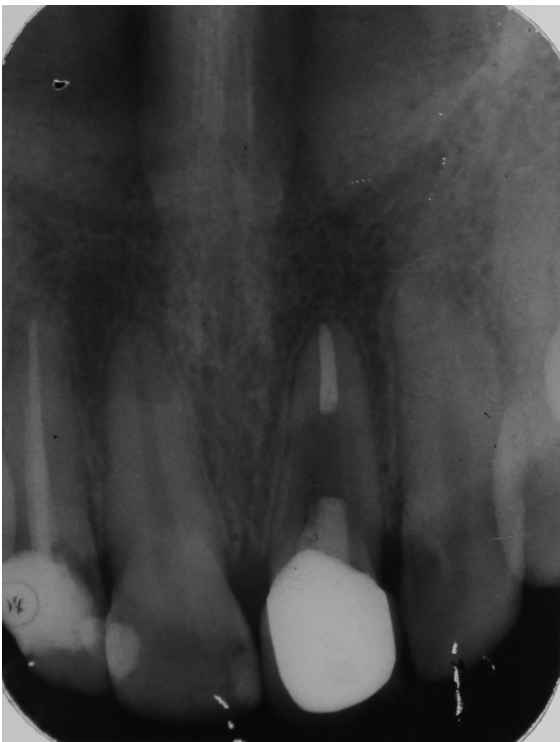
Figure 2. Preoperative Radiograph

Past dental history revealed endodontic treatment followed by post and core in the same tooth. Radiographic analysis revealed presence of guttapercha at the apical third of the root and a short fibre post in place (Figure 2). Since the crown was mobile it was removed to reveal the remaining tooth structure. Upon clinical examination, extensive destruction of the coronal tooth structure upto the cervical area was noted (Figure 3). Furthermore, upon closer clinical inspection, it was observed that the root was perforated on the buccal and mesial aspect. Taking into account the compromised tooth structure and overall prognosis, the patient was presented the option of having the tooth extracted followed by a single tooth implant

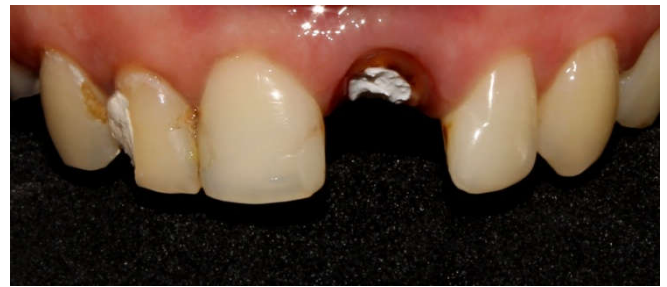
Figure 3. Preoperative intraoral view following crown removal

or full partial denture spanning #11 to #22. However the patient expressed her desire to retain and restore the tooth conservatively owing to the cost factor. Managing this case without extraction, but conservatively was not just tricky but challenging as well. The primary goal was to ensure minimal removal of remaining tooth structure and provide intra-radicular reinforcement.

- Root perforation repair with Mineral Trioxide Aggregate (MTA)
- Root reinforcement with FRC and Fibre post
- Core build up with FRC
- Full crown in #21

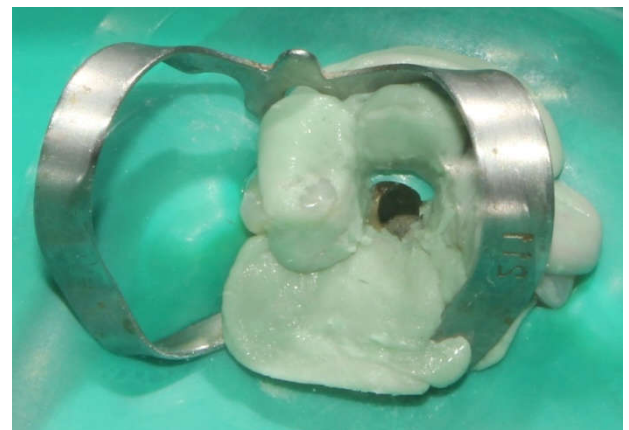
Figure 4. Rubber dam and rubber base impression material isolation

At the first appointment, pre-treatment photographs were recorded. Isolation was achieved with the help of rubber dam to provide a controlled operating field. Since the tooth was fractured at the cervical area, the tooth was further isolated with a rubber base impression material in order to prevent moisture contamination (Figure 4). The canal was thoroughly cleaned using copious amount of 3.5 % sodium hypochlorite solution to successfully disinfect the canal. The canal was then dried with paper points. MTA (Angelus, Londrina, PR, Brazil) was mixed according to the manufacturer's instructions and placed with the help of MTA carrier. The MTA was condensed into place with a plugger to seal off the perforation (Figure 5). The entire procedure was carried out with the aid of 3.2x surgical loupes with fiberoptic light source that permitted magnification, better illumination and improved visualization of the working field. A damp cotton pellet was placed over the orifice and the tooth was sealed with an interim restoration.

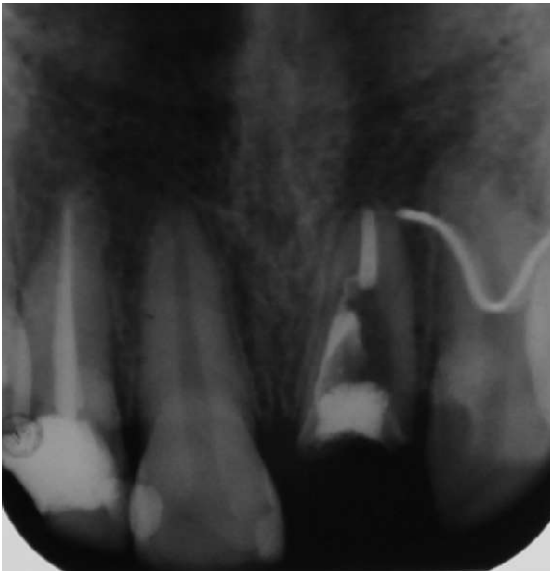
Figure 5. Perforation repair with MTA

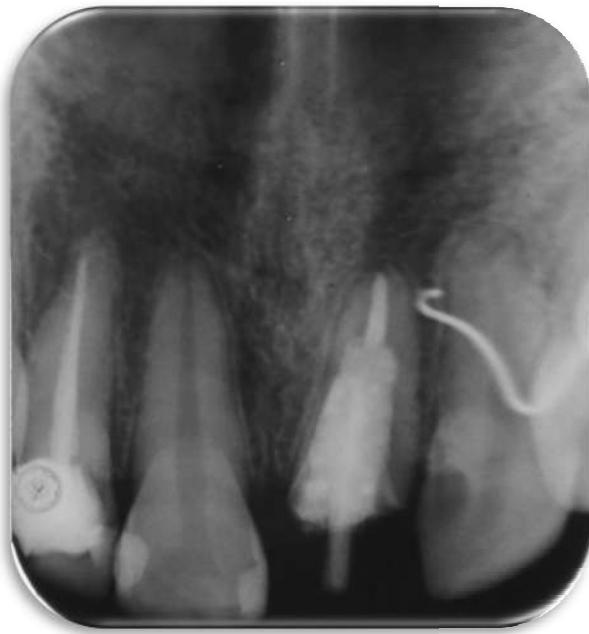
Figure 6. Placement of FRC and fibre post

Since the inner root dentin was considerably compromised in thickness, it was elected to restore the same with fibre reinforced composite. EverX Posterior (GC Dental Products Corp., Aichi, Japan) was selected for the procedure. The tooth was isolated using the same method as described above and the adhesive protocol was followed, which included etching with 36% phosphoric acid (Conditioner 36, Dentsply DeTrey) for 10 seconds, thorough washing with water and brief blot drying. Two coats of the total etch bonding agent (Prime and Bond NT, Dentsply Caulk, Milford, DE, USA) was applied with the applicator tip, lightly air-dried for 10 seconds, and light-cured for 10 seconds. Following this, the FRC was extruded from the compoule and compacted into the root circumferentially in order to rebuild the lost dentin and restore the root close to its original form. Each increment was light-cured for 20 seconds. A glass fibre-reinforced composite post of a suitable size was intermittently placed in the canal to adapt the FRC to the walls of the root and also ensure adequate space for the post placement.

Once the inner dentinal wall of the root was satisfactorily rehabilitated, the fibre post was cemented using self-adhesive resin cement (RelyX U200; 3 M ESPE, Seefeld, Germany), as per manufacturer's recommendations (Figure 6).

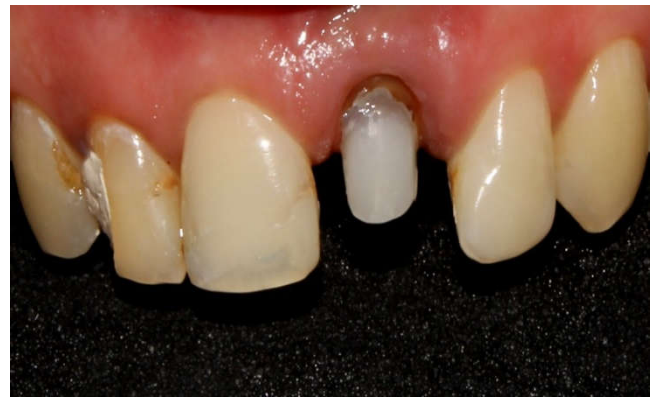
Figure 7. Core build up and crown preparation

Two coats of the total etch bonding agent (Prime and Bond NT, Dentsply Caulk, Milford, DE, USA) were applied to the extruded part of the fibre post with the applicator tip, air-dried for 10 seconds, and light-cured for 10 seconds. FRC was then extruded from the compoule and layered around the post sequentially in 2 mm increments to form the core.

The final phase of the treatment included the prosthetic rehabilitation. Tooth preparation was carried out for #21 with a circumferential 2mm shoulder finish line to receive a full ceramic zirconia crown (Figure 7).

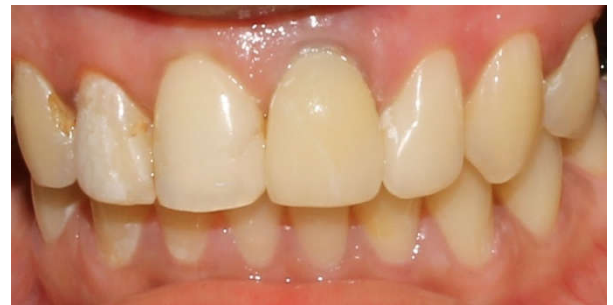
Figure 8. Following crown cementation

Impression was made with addition silicone impression material (Aquasil, Dentsply, Germany). Provisional crown was fabricated with autopolymerising resin (Visalys Temp, Kettenbach, Germany) and cemented with non eugenol luting cement (Rely X Temp NE, 3M ESPE, Germany). Once the zirconia coping was fabricated, try-in was carried out to assess the marginal fit. There after the crown was fabricated and tried intraorally for marginal fit, adaptation, occlusion and shade. The prosthesis was then finished, glazed and cementation was carried out with dual cure resin cement (RelyX U200, 3M ESPE, Germany) (Figure 8) Figure 9 shows the clinical appearance of the tooth after a gap of 3 years. The patient had no complaints and the tooth appeared to be functioning suitably well.

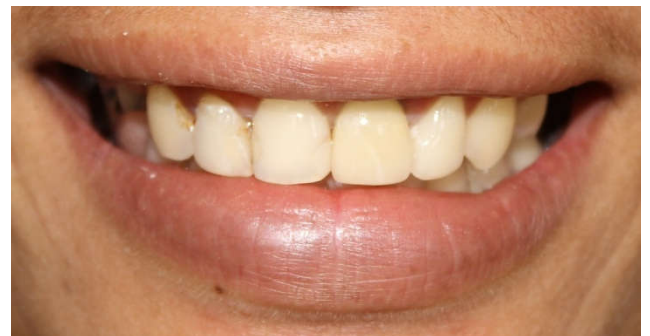
Figure 9. 3 year follow up
