INFLUENCES OF CLIMATIC CONDITIONS AND EROSION ON THE STABILITY OF DRINKING WATER SUPPLY PIPELINES IN CENTRAL AFRICA: THE CASE OF KINSHASA

Alassane TOURE^{1,*}, Dr. Sory DIALLO², Dr. Kadaouye DAMBA¹, Adjaraou Traore¹ and Dr. Mahamadou Alassane¹

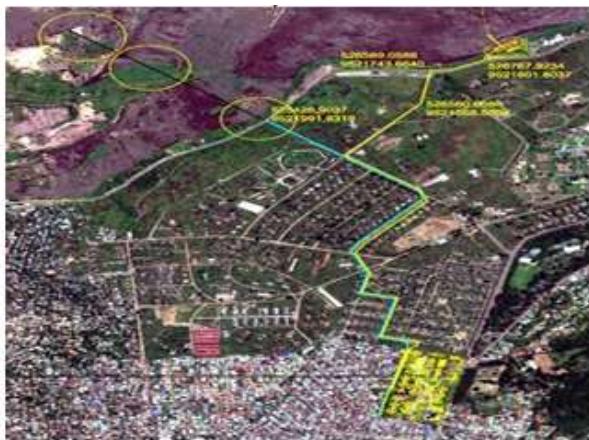
Figure 1. View of the PDMRUK-KIN ELEND network

Study Area Description: This study focuses on the intervention zone of the Kinshasa Multisectoral Development and Urban Resilience Project (PDMRUK-KIN ELEND) in western Kinshasa. Over the 30-month project period, the scope of works included:

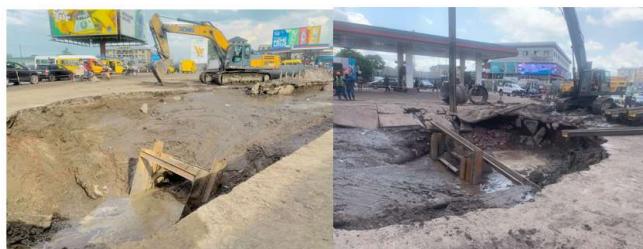
Figure 2. Landslides during the installation of DN 1400 FD pipes

Field Observations: Frequent collapses and fissures were observed along multiple sections due to erosion. At some locations, ground movements occurred during trench excavation, forcing route

modifications and creating recurring alignment issues. Quantity discrepancies frequently caused disputes between site inspectors and contractors.

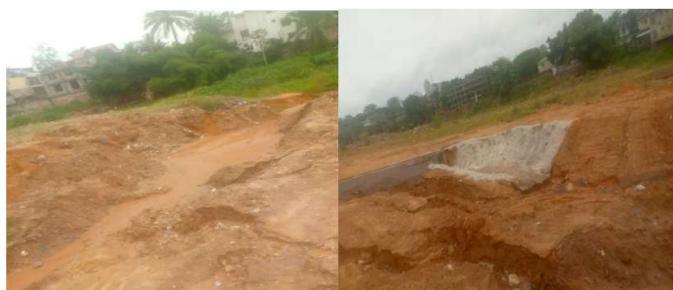
Furthermore, it is after installation that the cracks spread, causing landslides that sometimes attempt to spread under certain structures or weaken the condition of roads.

Figure 3. Effects or impacts on the ground after installation of the DN800

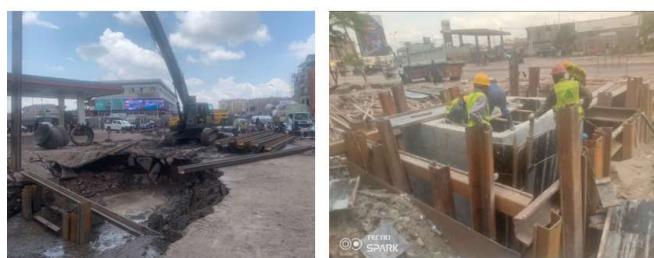
Proposed Operations for Work Continuity: Soil fragility during DWS works in Kinshasa presents a major challenge. To mitigate these risks and ensure project progress as well as protection of underground infrastructure—key assets in urban environments (6). Sheet piles and replacement of excavated soil with imported fill were recommended. This enhances ground stability and provides better protection of trench backfilling against erosion and water flows.

Figure 4. Sheet pile protection operations during construction work
