RESEARCH ARTICLE

EXPERIMENTAL STUDY ON ENERGY DISSIPATION CAPACITY OF 3 BAY 4 STOREY MASONRY INFILLED R.C FRAME UNDER CYCLIC LOADING

Citation: Sathiaseelan, P. and Arulselvan, S., 2015. "Experimental Study on Energy Dissipation Capacity of 3 bay 4 storey Masonry Infilled R.C Frame under Cyclic Loading ", *International Journal of Current Research*, 7, (12), 23639-23642.

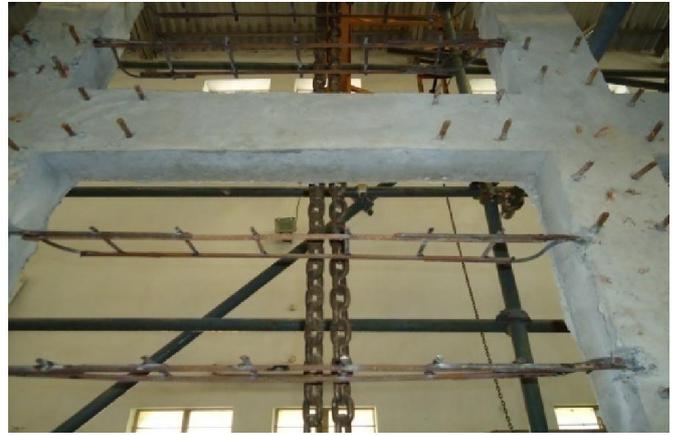
Figure 1. Reinforcement strip

The frame was cast using M₃₀ concrete mix. Test cubes of size 150x150x150mm and prisms of size 100x300mm were cast. The test specimens were tested after 28days curing and compared with the specified strength and found to be satisfactory. The frame was erected on the test floor. The reinforcement strip was as shown in Figure 1.

Two numbers of 6mm ms rods extended from frames were tied up with distributors in between the two layers of brickwork. The brickwork was carried out with bricks of size 220x100x70mm with a compressive strength of 4.5N/mm². The reinforcement was embedded with 20mm thick concrete (M₃₀) strip as shown in (Fig3). The brick infill with RCC strip was as shown in Fig 2.

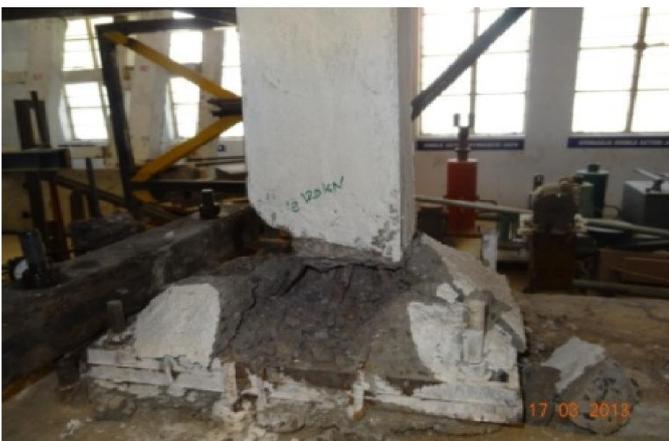
Figure 4. Final failure of frame

At 173kN the wind ward column failed due to short column effect as shown in Fig. 4.

At 50kN the cracks have been further developed for a length of 3-4cm. Increasing the load, budding major cracks were found and the concrete strain was not noted further. At 90kN few minor cracks developed in the brick layers for 2-4mm length in the bottom storey. At 120kN minor cracks have been found in the bottom of the foundation in the tension side of the frame. At 150 kN horizontal cracks were found in the brickwork.

3. At the ultimate stage the frame system dissipated high energy due to the ductile behavior Which is very much required to resist ground motion.
4. It was observed that at the ultimate stage infill did not fall as debris due to strips. The cracks in the infill were horizontal in nature
5. This crack pattern was due to proper interfacing of frame and infill monolithic action of the frame and infill.
6. The failure occurred due to the yielding of reinforcement in the column. To avoid such failure column junction may be strengthened or number of RC strips may be reduced.
