### HISTORICAL EVENTS AND LAND USE CHANGES SHAPING THE ISIPINGO RIVER CATCHMENT, KWAZULU-NATAL, SOUTH AFRICA

Pillay, R. K., Pillay, S. and \*Ballabh, H.

Citation: Pillay, R. K., Pillay, S. and Ballabh, H. 2016. "Historical events and land use changes shaping the Isipingo river catchment, Kwazulu-Natal, South Africa", *International Journal of Current Research*, 8, (06), 32260-32268.

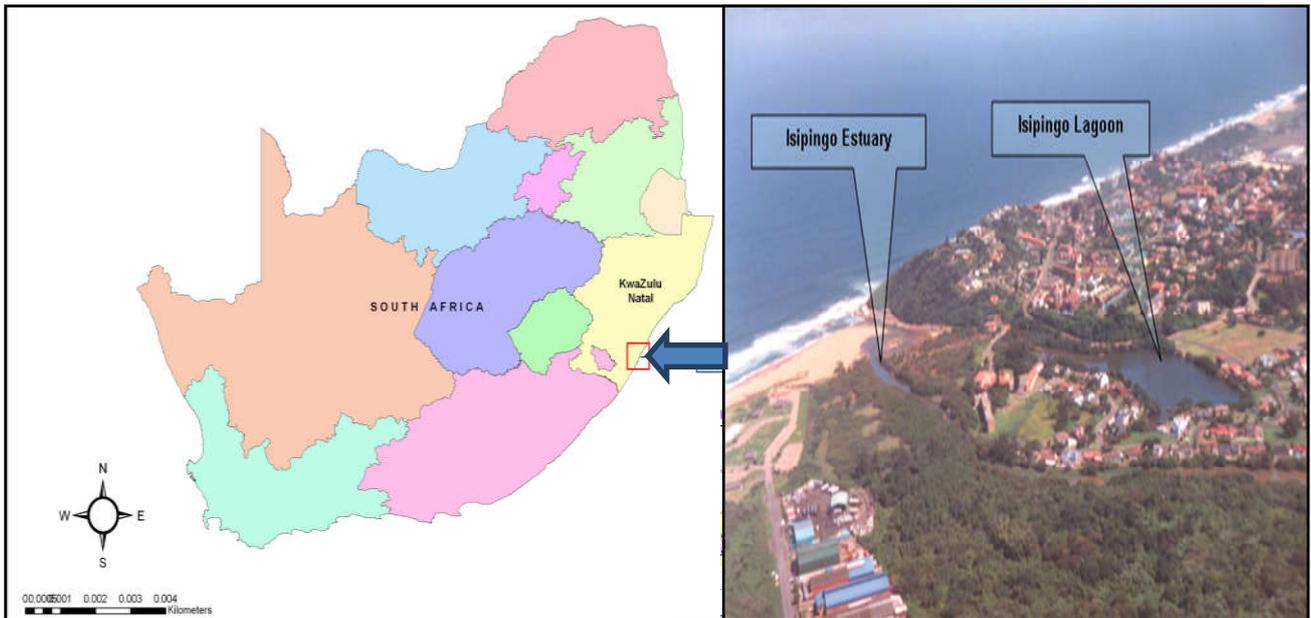
Fig. 1. Locality map depicting the Isipingo Estuary and Lagoon in 2002

The Isipingo catchment is one of the smaller catchments located in the province of KwaZulu-Natal, with an extent of approximately 50 km<sup>2</sup> (Fig.1). The length of the Isipingo River is approximately 27 kilometers (km), originating near the Iwabi area (Kalicharran and Diab, 1993, Brand, 1967). The importance of the catchment lies in the fact that it has become one of the most highly developed regions in KwaZulu-Natal. The Isipingo Lagoon and Estuary is located between 30°00'S and 30°57'E and is approximately 21 km south south-west of the Durban CBD (Fig.1). The main activities associated with the estuary and Lagoon is recreational, fishing and cultural practices and, at some parts of the river, poor communities living along the river have been observed using it for the

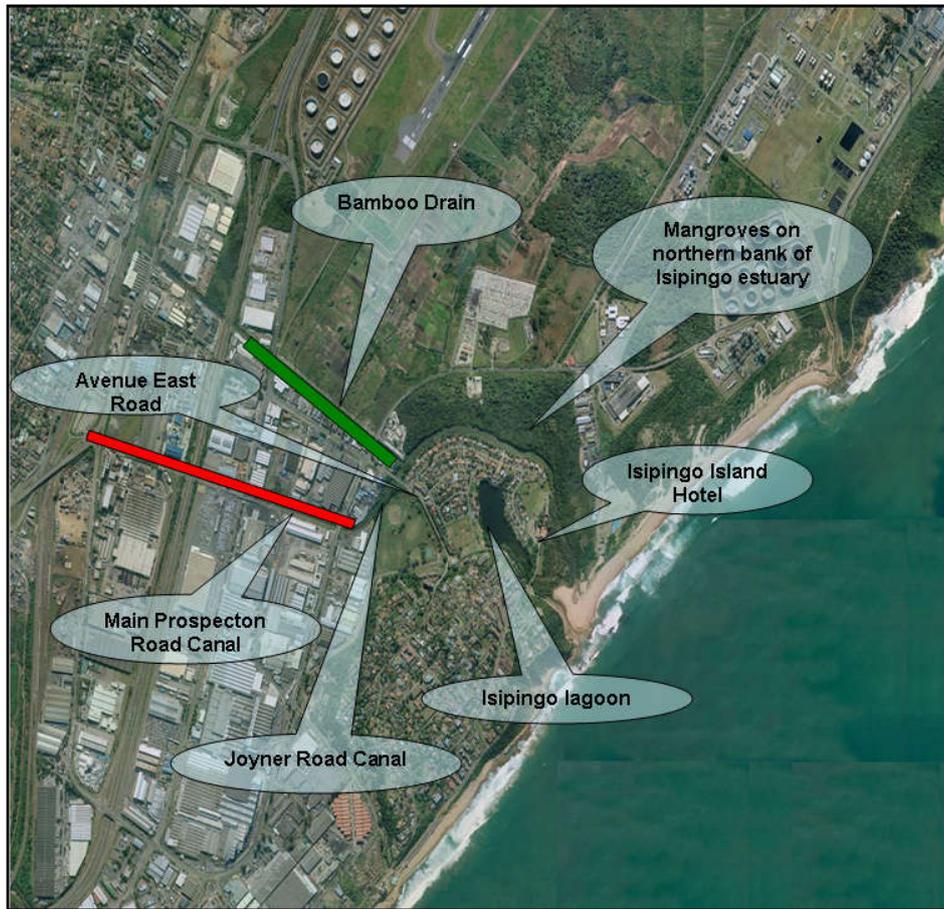
Fig. 5. Isipingo Estuary and Lagoon showing mangroves and canals (2008) (eThekweni Municipality, 2010)

Today, the northern bank of the estuary is observed to be well vegetated with mangroves while there is no riparian vegetation encompassing the Lagoon (Fig.5). Forbes and Demetriades (2008) iterated that the eastern tip of the island and the area around the Island View Hotel are also well vegetated with mangroves while the southern bank in the region of the mouth has been cleared of vegetation for a road and car park (Fig. 5). The southern bank of the main channel is fringed with a narrow strip of mangroves. The current type of mangroves comprise primarily of *Avicennia marina*, *Bruguieragymnorhiza* and *Rhizophoramucronata* (species of red mangrove found on the northern banks of the Isipingo Estuary) and inhabits an area of approximately 12.7 ha (Rajharen and Adams, 2006).

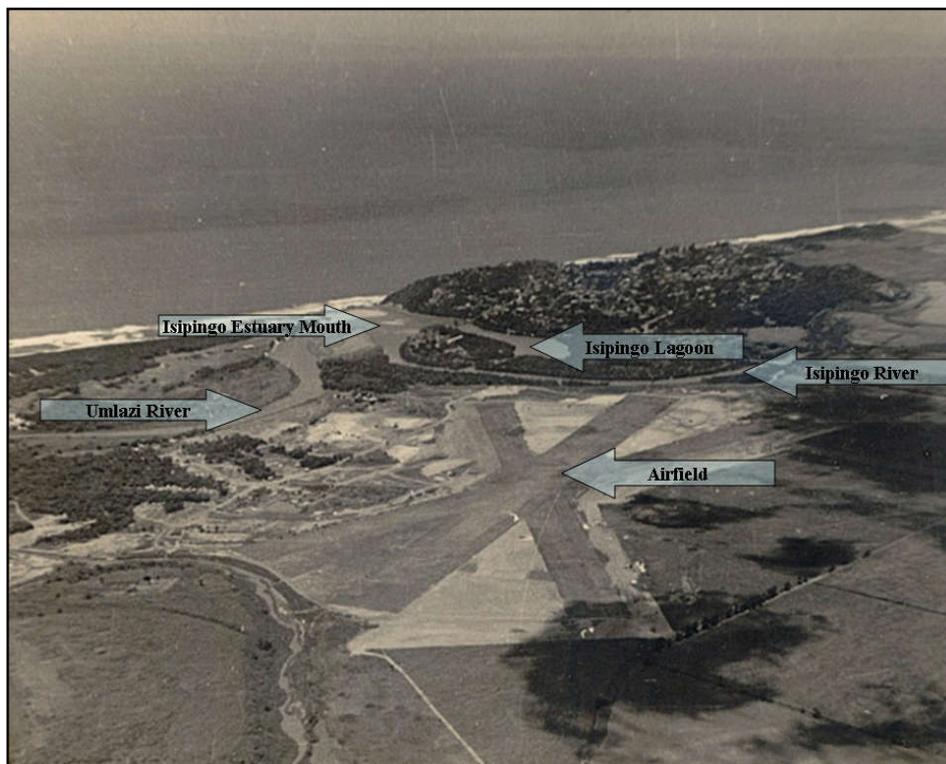
Fig. 6. Isipingo Estuary and Umlazi River in 1942 (eThekweni Municipality, 2010)

The severe reduction in flow to the Isipingo Estuary diminished the scouring effect at the mouth leading to wave induced sand accumulation and mouth closure. The mouth closed semi-permanently in 1952, and mechanical breaching was initiated (Forbes and Demetriades, 2008). An attempt to increase tidal interchange was undertaken in 1955 by installing a one metre diameter steel pipe through the sand bars (Ward, 1980). The failure of this attempt prompted the construction in 1961 of two concrete pipes of one meter diameter each below the sandbar (Ward, 1980) which today still provides some tidal exchange (Fig.6).

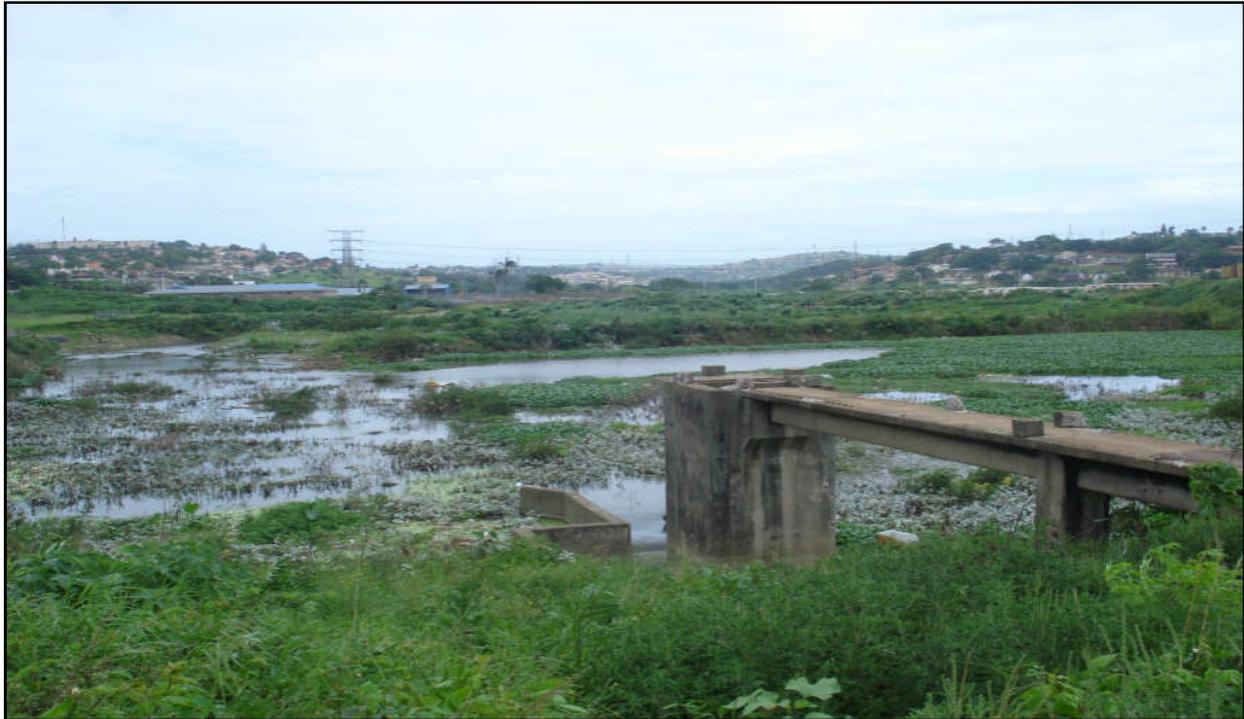
**Fig.7. The Diversion Works System (2010) showing the large concrete structure which houses the sluice gates that allows pooled water to flow into the PCS**

The pressures arising from the need to develop the Prospecton Industrial area (late 1960s) resulted in the flow of modification of the upper Isipingo River with the construction of the DWS in 1969/1970 (Figure 4). This system together with sluice gates was installed at the head of the Prospecton Canal System (PCS) (Swart, 1987) to regulate the flow received from the upper catchment and to permit a controlled flow to the PCS. The Isipingo River was canalized for more than 1 km above the Avenue East Bridge during this period to assist with stormwater drainage (Forbes and Demetriades, 2008) and this canal system is still in existence today. The system was designed to divert high flow levels to the Mbokodweni River during times of floods while permitting low flow levels through to the PCS and eventually the Isipingo Lagoon and Estuary (Philip, 2010). The flow of the Isipingo River was thus reduced to 3 million m<sup>3</sup>/year, only three percent (3 %) of its original flow (Swart, 1987). Due to poor maintenance and mechanical problems of the sluice gates, the flow has often been reduced further (Swart, 1987).

In November 2009, the Coastal, Stormwater and Catchment Management Section of the eThekweni Municipality undertook remedial measures. Accumulated sediment and water hyacinth was removed from the pond ahead of the DWS. The pond was created to channel and slow down the water prior to flowing through the DWS. Further excavations of the pond were undertaken and a concrete trash tract with palisade beams was installed instead of steel to dissuade theft. Maintenance is expected to be conducted every 3 months as well as immediately after heavy rainfall events to maintain the water height, remove water hyacinth and sediment in the pond. According to Sooklall (2010), the maximum flow that can be permitted through the inlet of the sluice gates calculated by engineers of the eThekweni Municipality is 5.4 m<sup>3</sup>/s. Repairs to the DWS have been undertaken but due to the irregularities in the maintenance of the system, there are periods during which the Isipingo River, just above the DWS, is still being diverted to the Mbokodweni River.

The Isipingo Flats from Avenue East (main access road to Isipingo Beach) was infilled in 1966, together with the canalization of the river and its tributaries to allow for industrial development (Kalicharran, 1990). The Prospecton area was infilled to three meters (3m) above mean sea level (Ward, 1980) and, in 1969 this level was increased using dredged material from the Isipingo Lagoon, Estuary and the river (Fig. 7) (Ward, 1980).
