International Journal of Current Research Vol. 8, Issue, 05, pp.32187-32195, May, 2016 INTERNATIONAL JOURNAL OF CURRENT RESEARCH

RESEARCH ARTICLE

SUNDARBAN EMBANKMENTS- A STUDY ALONG SURYABERIYA RIVER, SAMBHUNAGAR ISLAND, GOSABA, WEST BENGAL

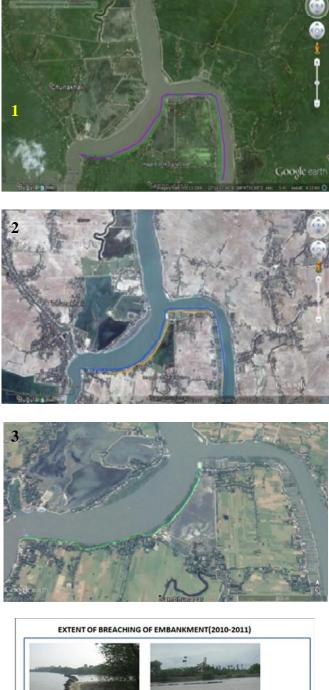
Fig. 10. Embankment breaching of Sambhunagar (clockwise from left 1- 2003-09, 2 - 10-13, 3 - 14 - 16 and 4 - photographic evidence)

The extent of breaching of embankments for Bairagipara, the surveyed area of Sambhunagar has been identified from the images of Google earth. The extent of breaching from the year 2003 to the year 2009 was 0.108 km^2 and the extent of breach from the year 2010 to 2013 was 0.115 km^2 . While from 2014

to 2016 the extent of embankment breaching has been reduced to 0.00175 km^2 showing a development of the situation.
